DINO RXT 220/280/72/92 OUTER BOOM REAR DEFORMATION

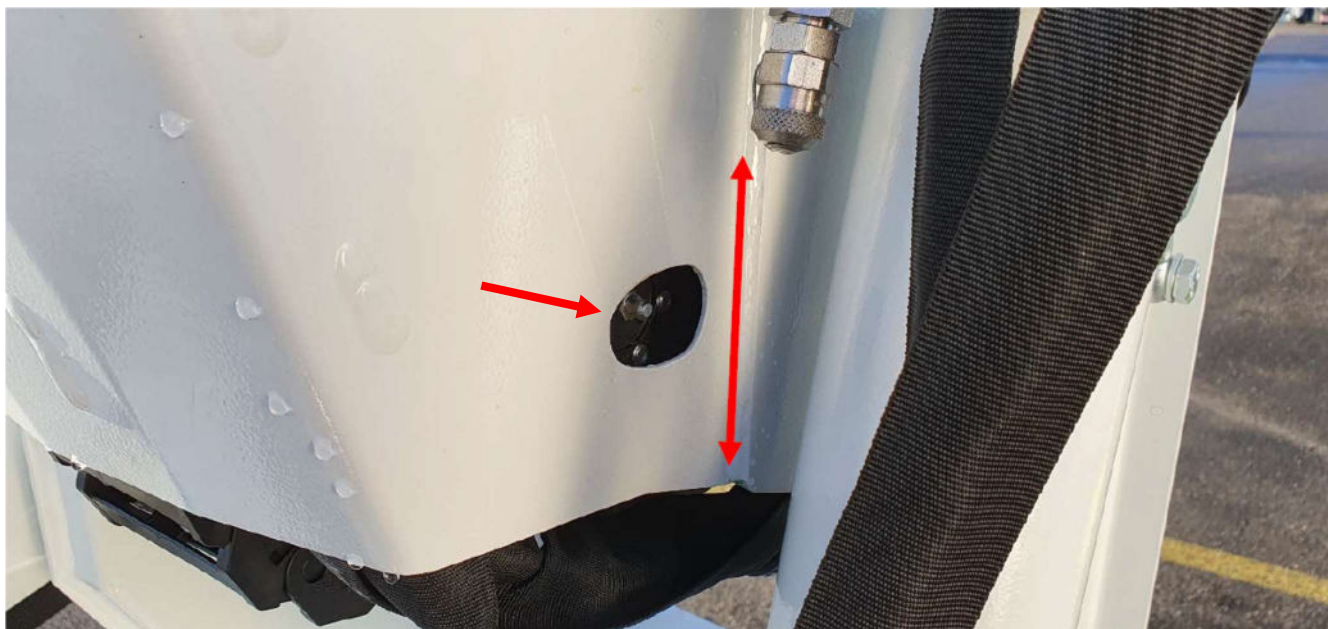
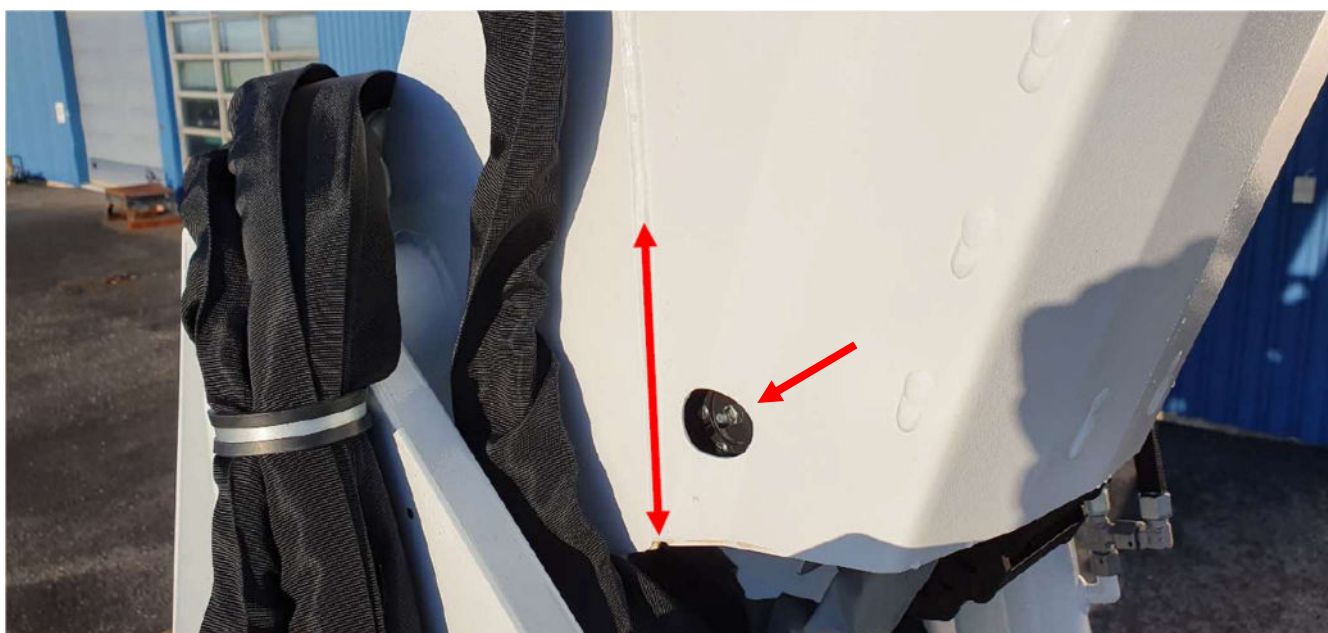
We have received information that DINO RXT outer boom may deform in extent that cracks appear. Therefore, an immediate inspection of the outer boom is required. The inspection can be done visually, no dismantling is necessary. Machine is to be driven on outriggers and boom lifted to its maximum angle. Below are pictures showing the location to be inspected. After the equipment has been checked according to the instructions, please notify techsupport@dinolift.com of all findings concerning this bulletin with reference to the serial number of the machine. If damage on the boom is discovered, the use of machine must be discontinued immediately and further instructions will be given by Dinolift or DINO distributor.

To solve this issue, immediate actions are being taken. Reinforcement plates are being developed and when tests have been conducted, repair instructions will be sent to all RXT machines involved in this bulletin and in cooperation with distributors work is to be scheduled. If no damage is found in this requested inspection, the use of the equipment can be continued normally while maintaining normal daily inspection schedule as instructed in the service manual. Paying special attention to the requested locations seen in the pictures.
